# MARYLAND HISTORICAL TRUST NR-ELIGIBILITY REVIEW FORM

Property Name: Christian Kemp Farmstead/Ballenger Farm Inventory Number: F-1-179

Project: Linton Property Agency: U.S. Army Corps of Engineers

MIHP # F-1-179  
Christian Kemp Farmstead  
Frederick, Frederick County, Maryland  
Photographer: Dean A. Doerrfeld  
Date of Photographs: 8 April 2005  
Location of Negative: MD SHPO

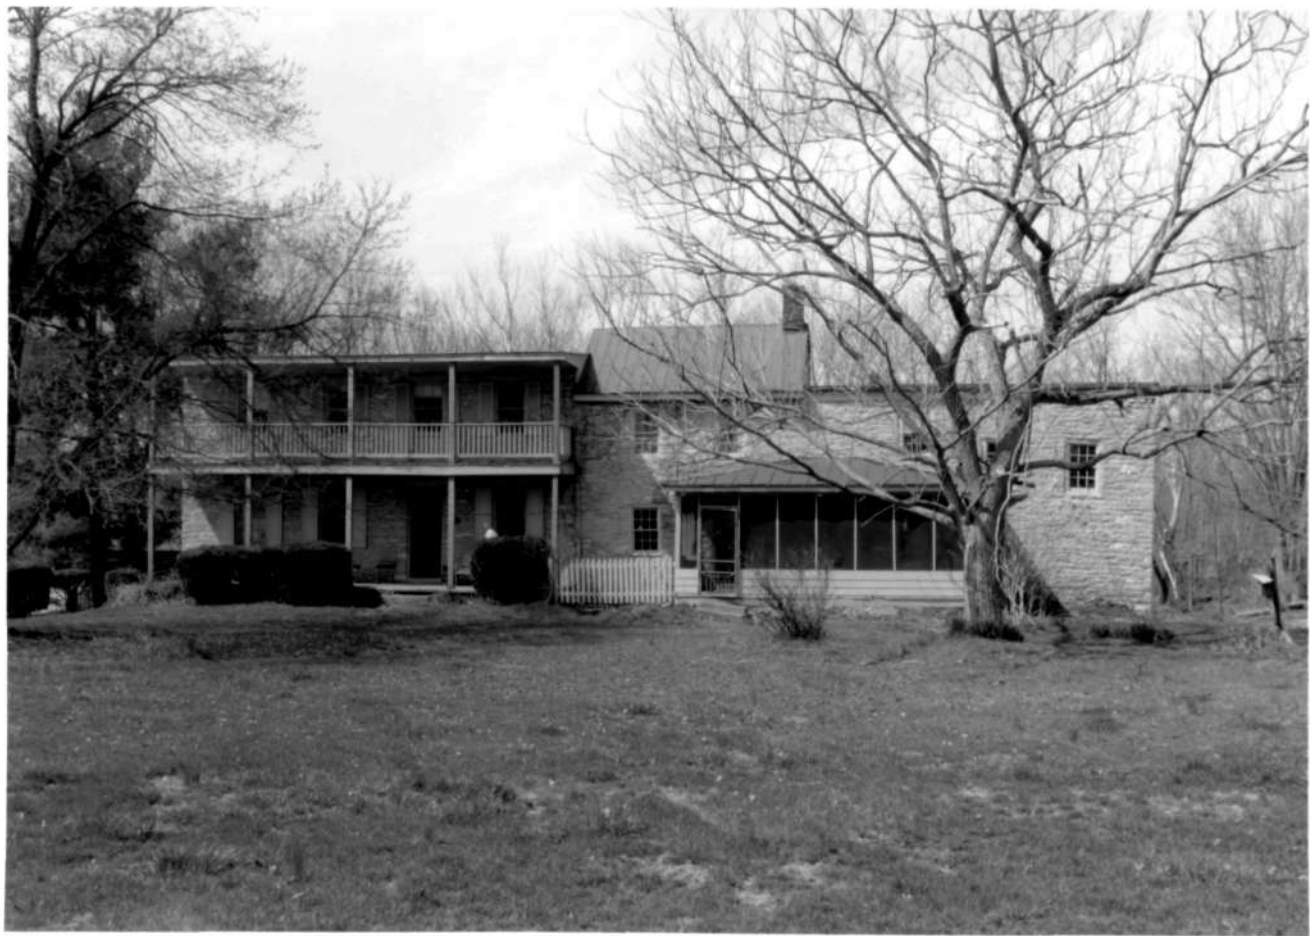
10F10

Facade of Christian Kemp House looking northwest

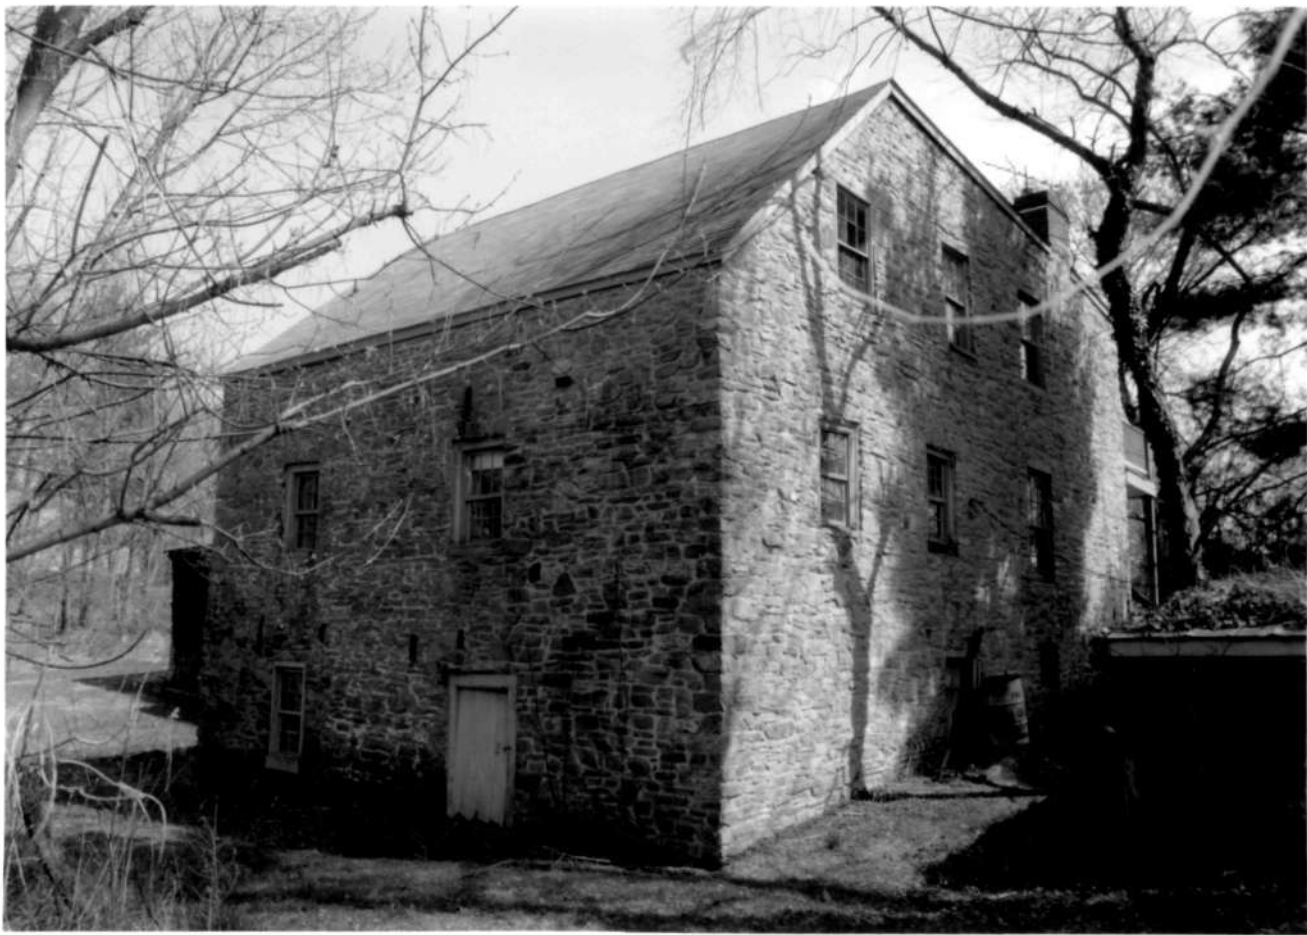
2 of 10

The rear or northwest wall of the first period is asymmetrically fenestrated and contains four openings, two on each level. The lower level is pierced by a six-over-six, double-hung wood-sash window to the left and a vertical batten door to the right. Repairs to the rear wall may have removed any supporting arches, and the openings appear to be framed by wooden lintels.

Northwest elevation of Christian Kemp House, Period I, looking  
east

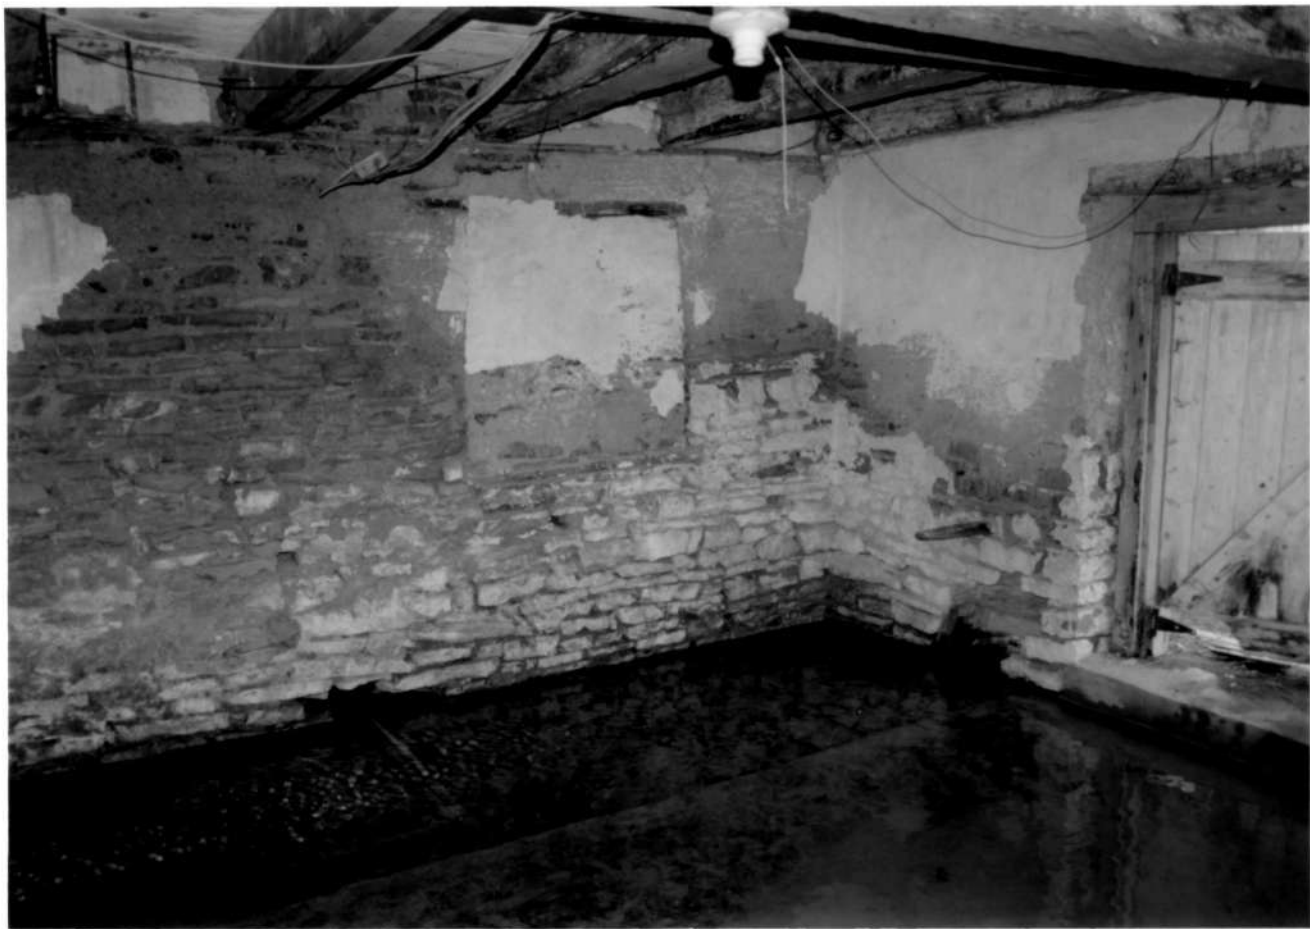
3 of 10

The cellar room of this section of the building is accessed through the vertical-batten door of the rear elevation. The room contains windows within its front and rear walls, and an infilled window in its southwest wall. The main feature of this room is the concrete trough along the southwest wall that channels the spring through the room. Spring water enters through the front wall, flowing through this room, and then exits the rear wall eventually reaching Ballenger Creek. Fragments of wood and pockets in the rubblestone masonry indicate a wooden shelf once spanned the depth of the building approximately three feet above the water. The upper two levels are single rooms with fireplaces along the northeast walls. Both rooms display moderate modification with modern appliances, wall coverings, and closets.

Interior view of cellar, Period 3 springhouse, looking  
northwest

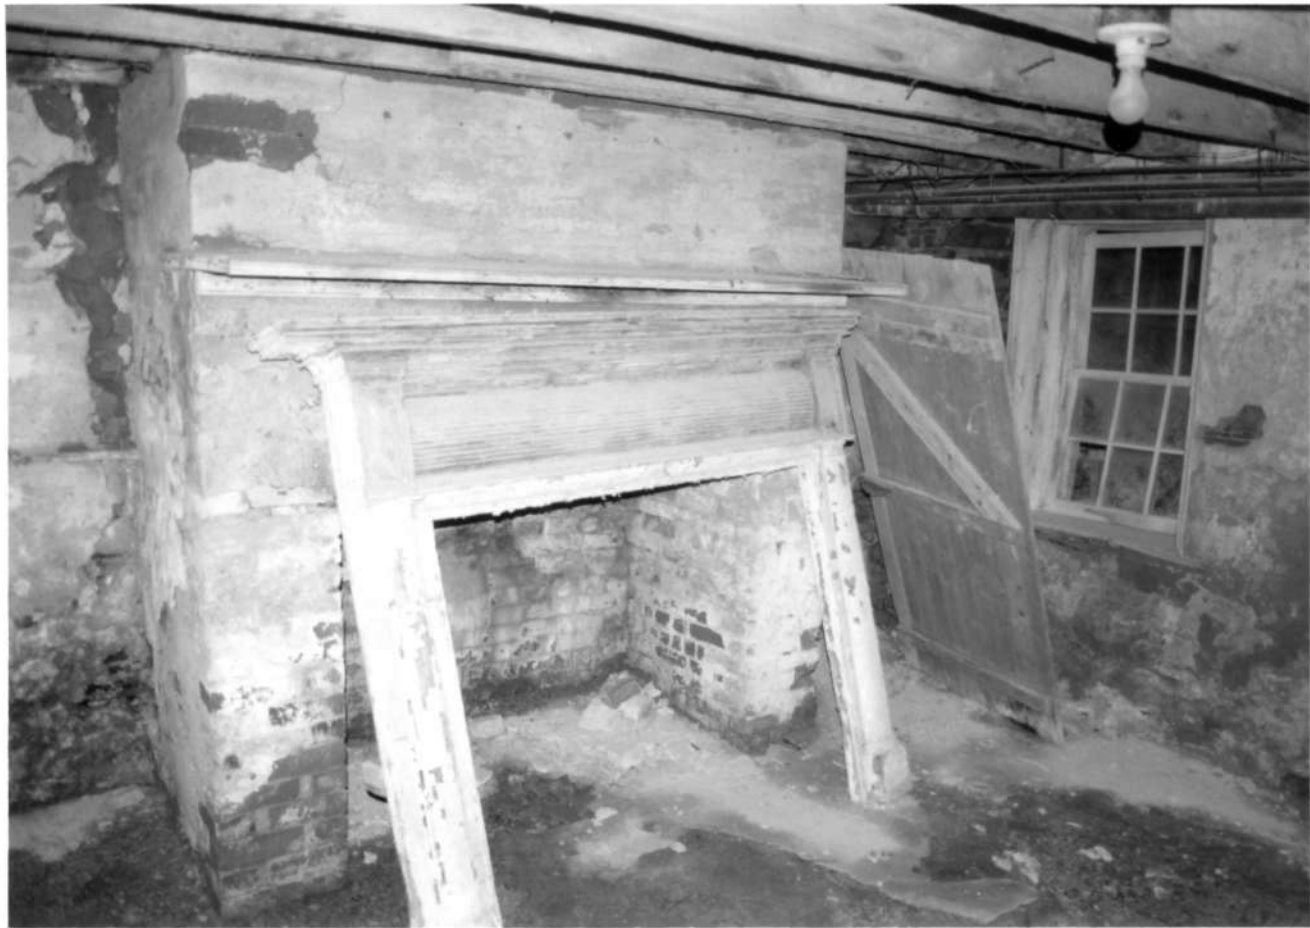
The lower room of the southwest stack is a cellar room accessed from the subterranean façade entry and the vertical batten door in the rear. It is heated by a brick fireplace. A Federal-style mantel currently rests against the masonry, but does not appear original to this location. A shelf with molded skirting lies above the firebox. The windows visible on the front and rear elevation light this room. A third entry opens the southwest wall of this room into the "springhouse" portion of the building. The double-leaf door is of braced, vertical-batten construction with heavy strap hinges. No stairs are present to provide communication with the upper levels.

Interior view of cellar, period 2 kitchen, looking east  
4 of 10

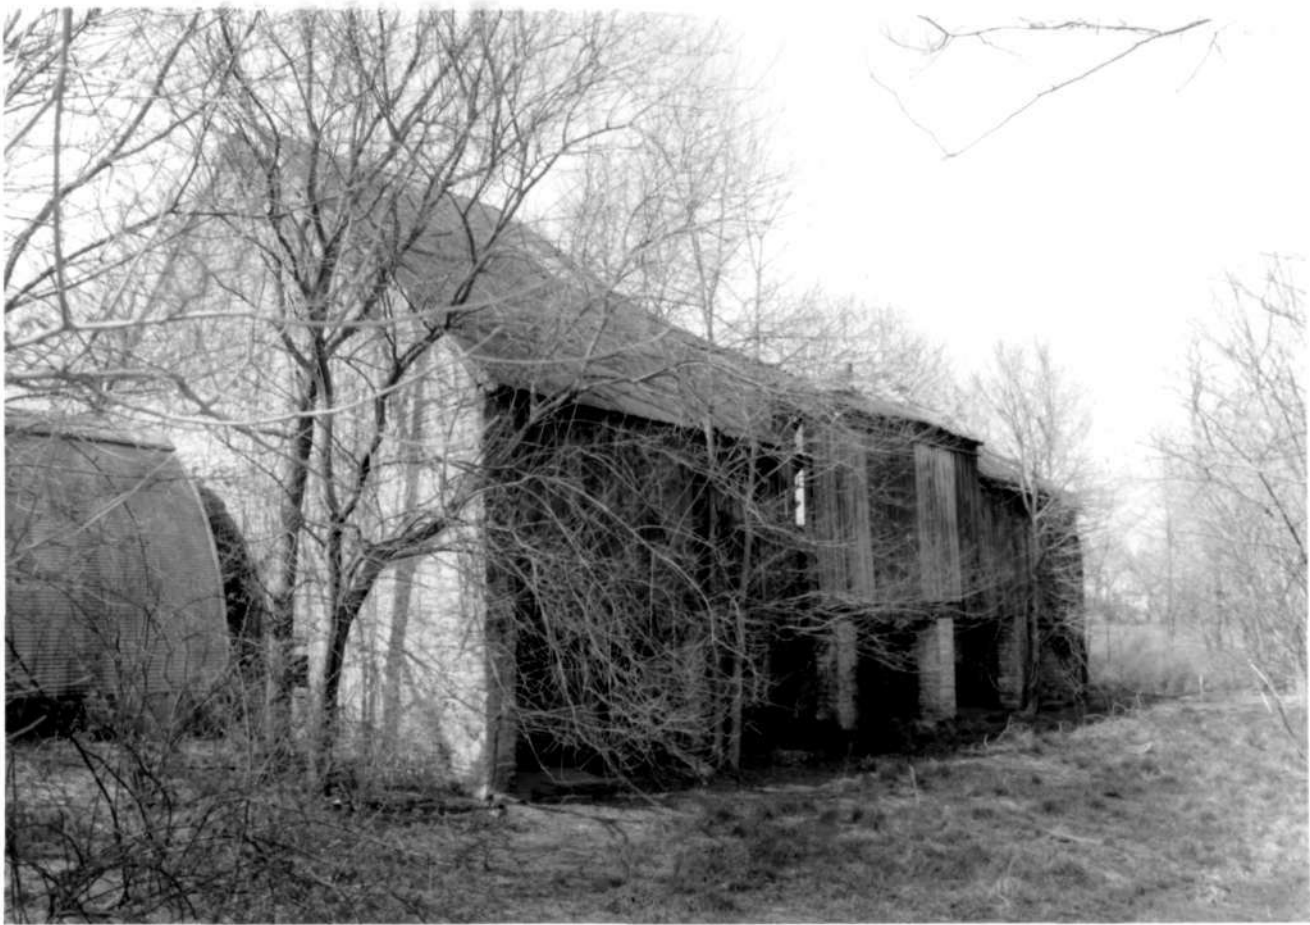
5 of 10

Approximately 350 feet west of the dwelling stands a stone and frame bank barn. The bank is constructed on the southwest of the barn with the stock pens accessible from the northeast. The rubblestone, masonry portion of the barn includes the foundation, rear walls, and both gable walls. The front wall is of frame construction and vertically sided. Closely resembling a forebay, the front of the barn overhangs the stall access and is supported by stone piers; however, this overhanging portion is contained within the stone gable walls and covered by the continuous pitch of the roof. The roof is covered with a combination of wood shakes and corrugated metal.

Southeast elevation of bank barn looking north

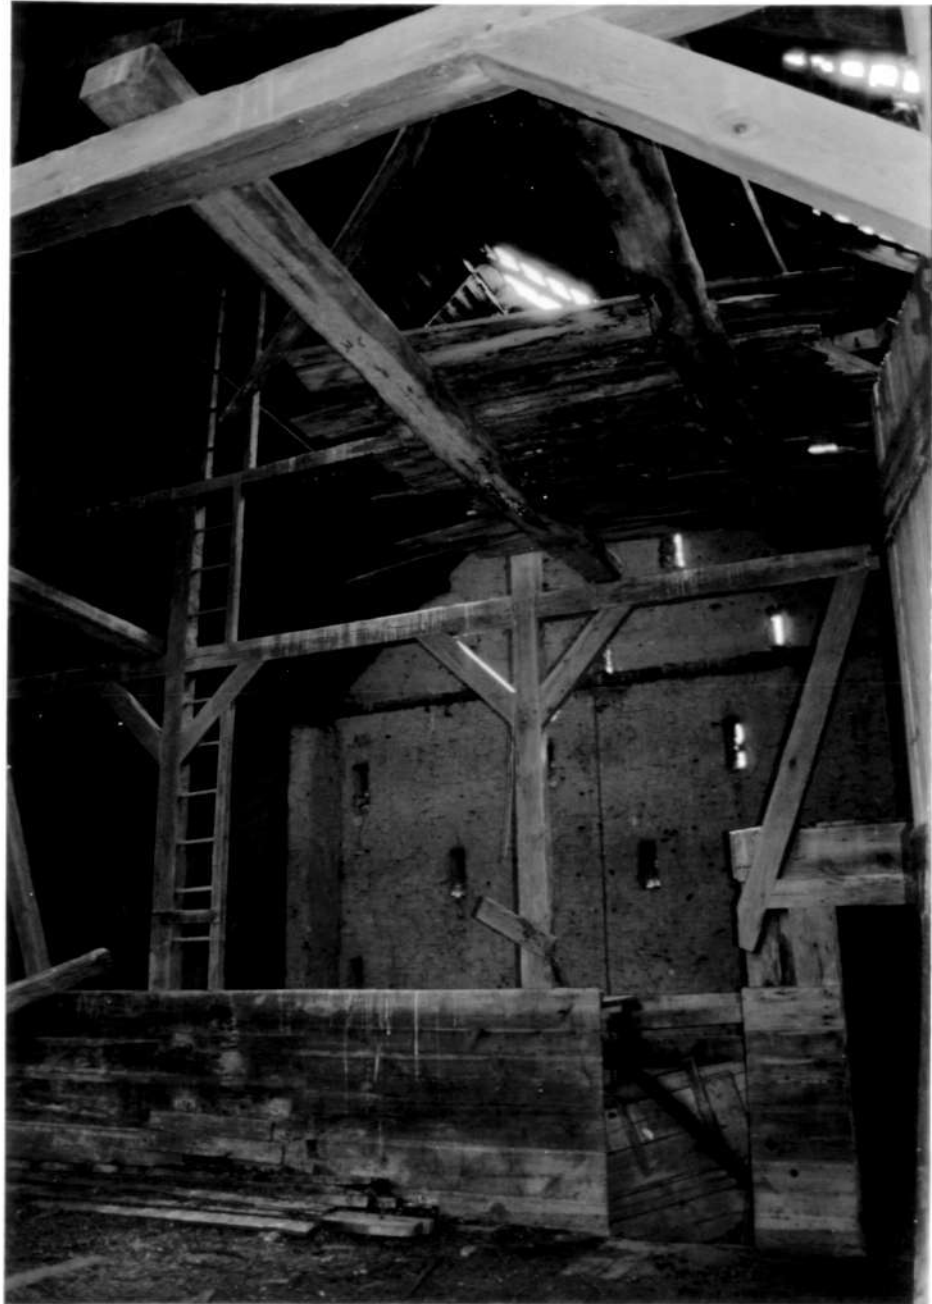
6 of 10

Entry to the barn is through sliding doors on the northwest elevation. The doors are contained within a slightly projecting roof structure. A similar overhang and paired sliding doors lies at the opposite end of the runway. The interior of the barn contains two bents defining the runway and mows. The heavy timber frame is largely of hewn material although some repairs have utilized circular sawn lumber. The bents are composed of heavy posts and girts with down bracing stretching from the intermediate girt to the floor. The plate is assembled of several structural members joined with splined scarf joints. The roof structure utilizes principal rafters and purlins fastened with through, mortise and tenons. Common rafters are lapped over the purlins. The masonry walls are parged on the interior and the gable walls are pierced by numerous, narrow, splayed ventilation openings.

Framing of bank barn looking southwest

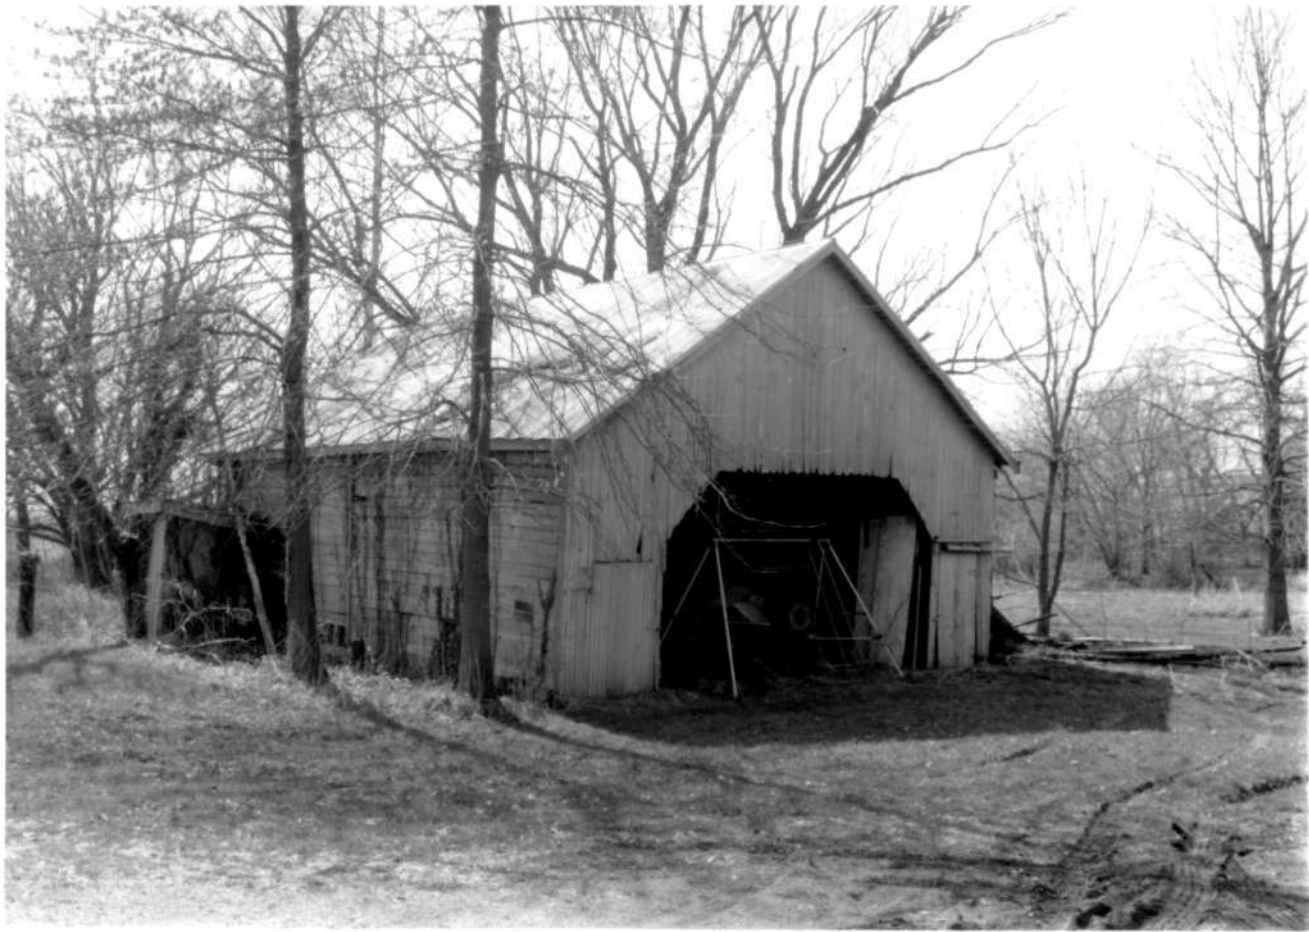
7 of 10

The remaining outbuildings are a front-gable, drive-through corncrib and wagon house and a concrete masonry unit chicken house. The crib is of frame construction and sheathed with vertical boards on the gable wall and horizontal board siding on the longitudinal walls. The roof is sheathed in metal panels. The chicken house retains some nesting boxes, but has been modified into a multi-purpose building with three, passage doors and replacement, metal-sash, sliding windows. The roof is covered with metal panels.

Northeast elevation of corn crib (non-contrib) looking southwest

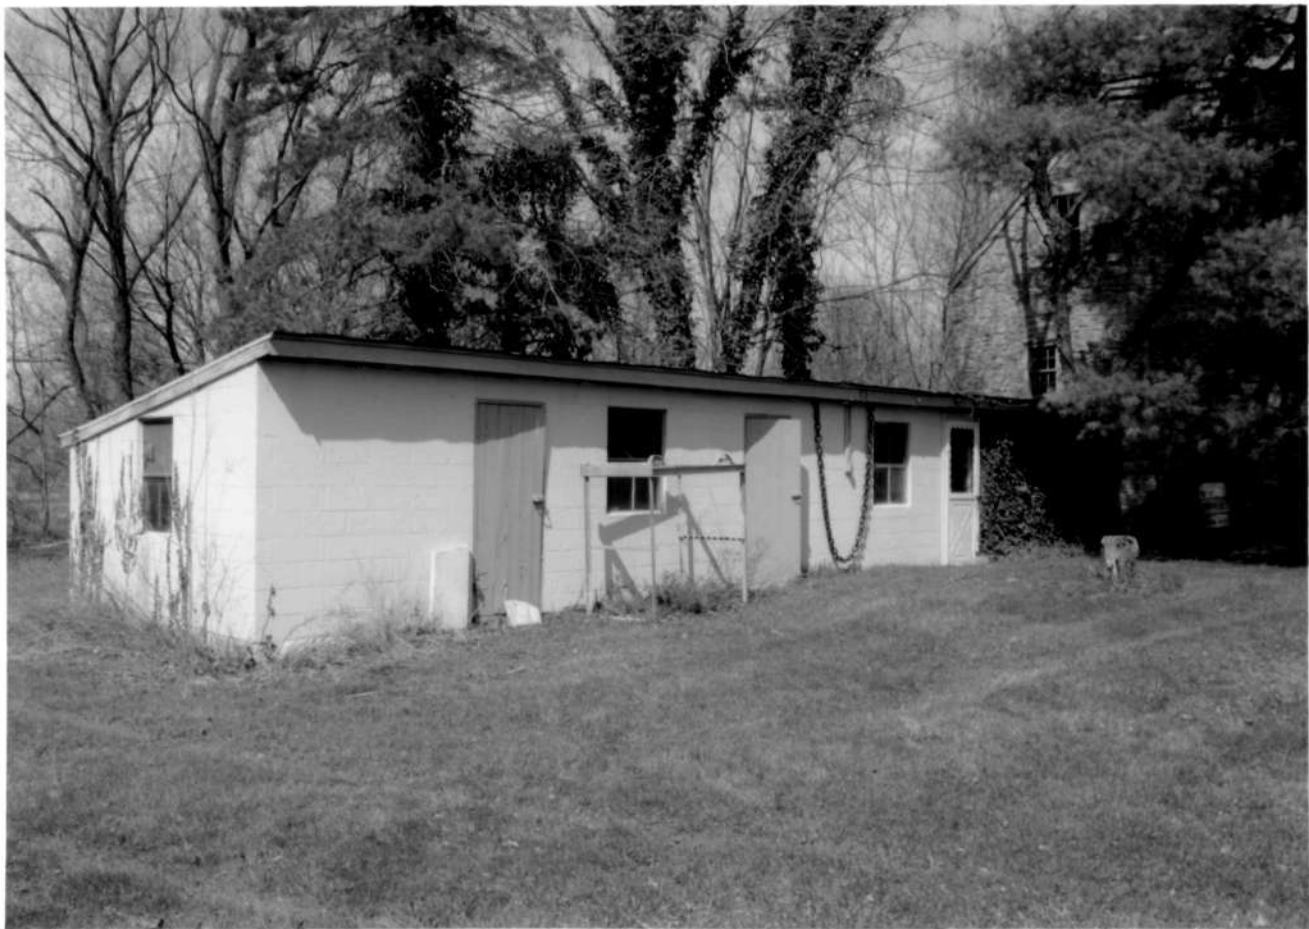
8 of 10

Southeast elevation of chicken house (non-contributing)  
looking north west

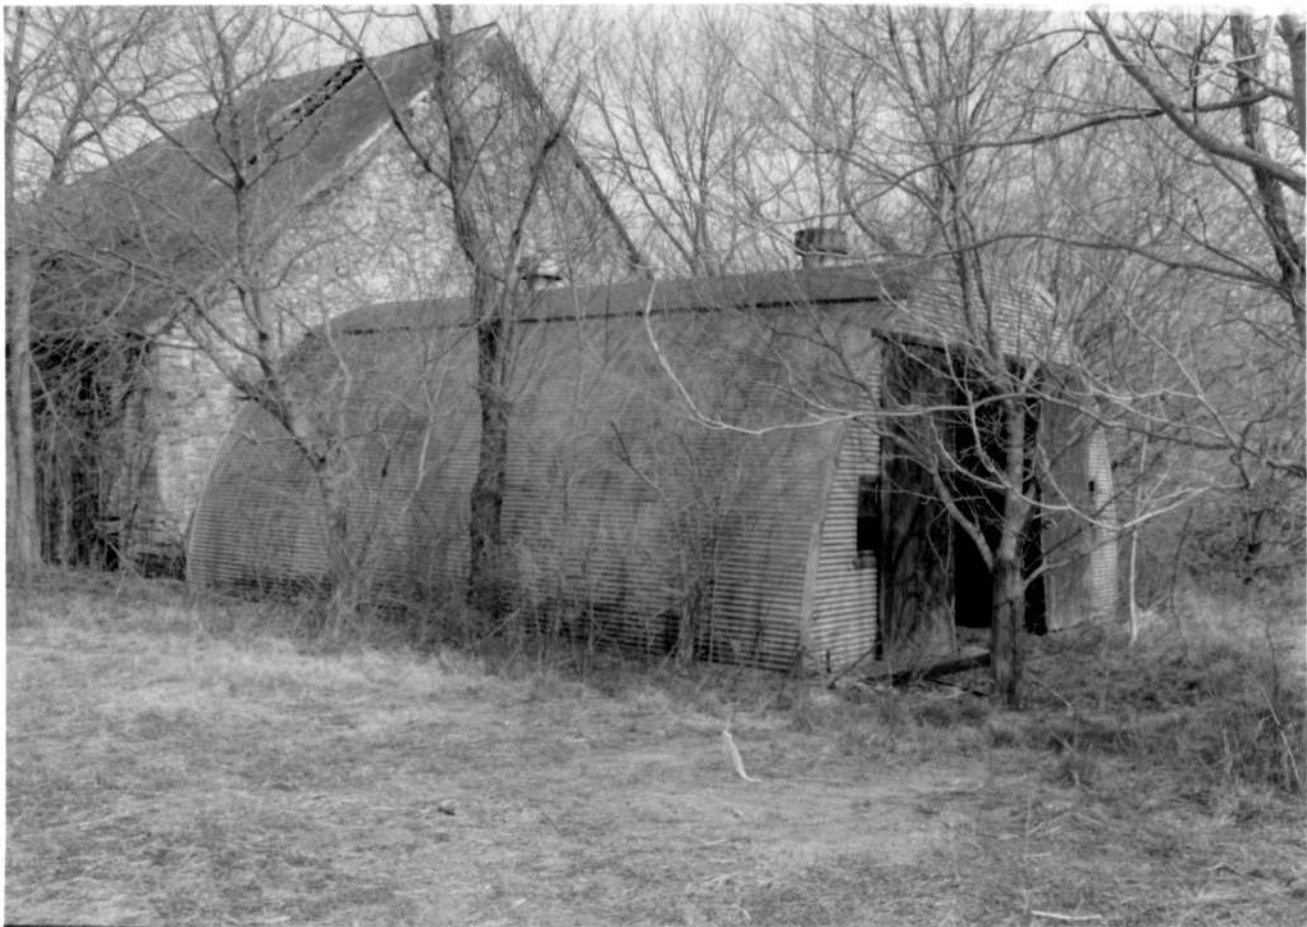
9 of 10

Immediately west of the barn is a corrugated metal, Quonset hut. The building contains two one-over-one, double-hung sash windows in its west elevation. The windows flank a pair of wooden, sliding doors. Two cyclone ventilators lie along the peak of the arched roof.

Quonset hut (non-contributing) looking southeast

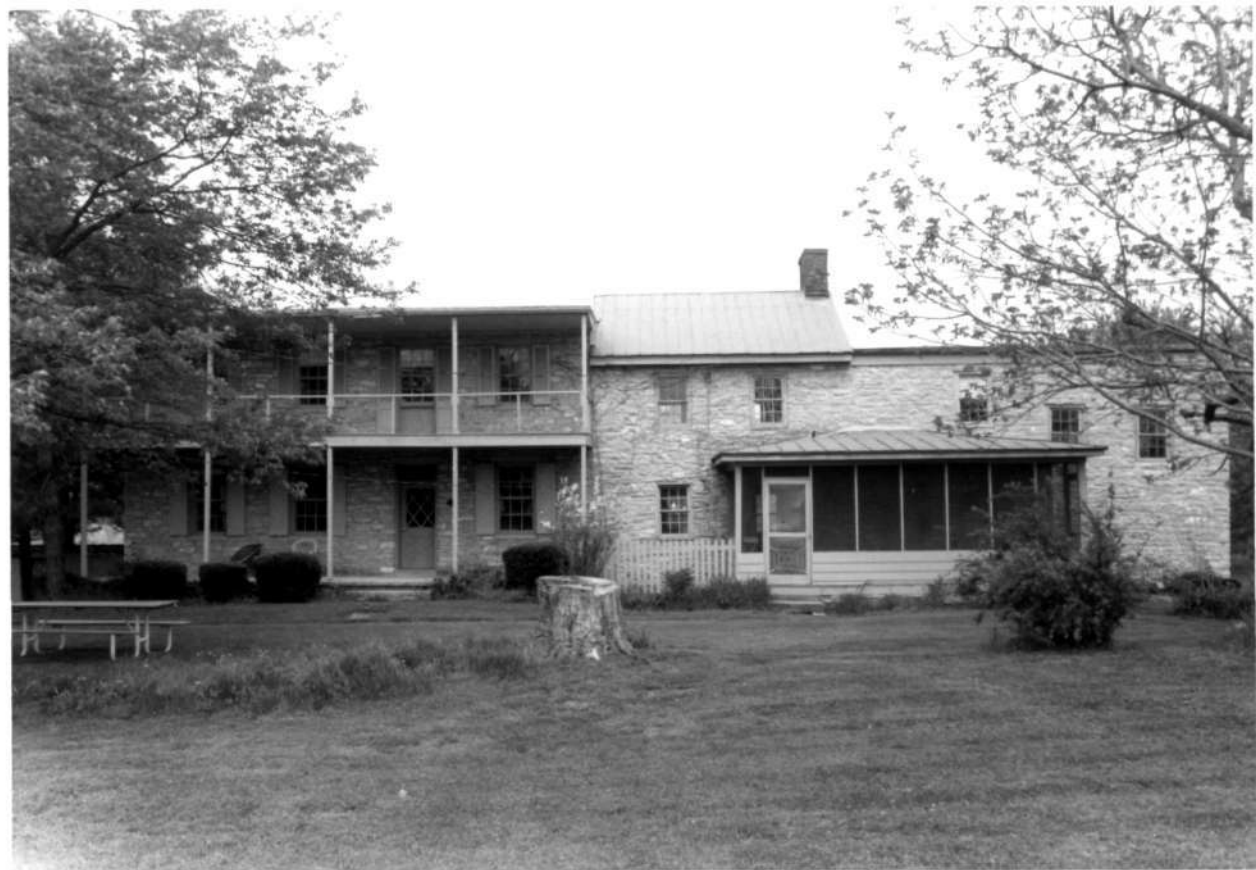
1/10

East elevation

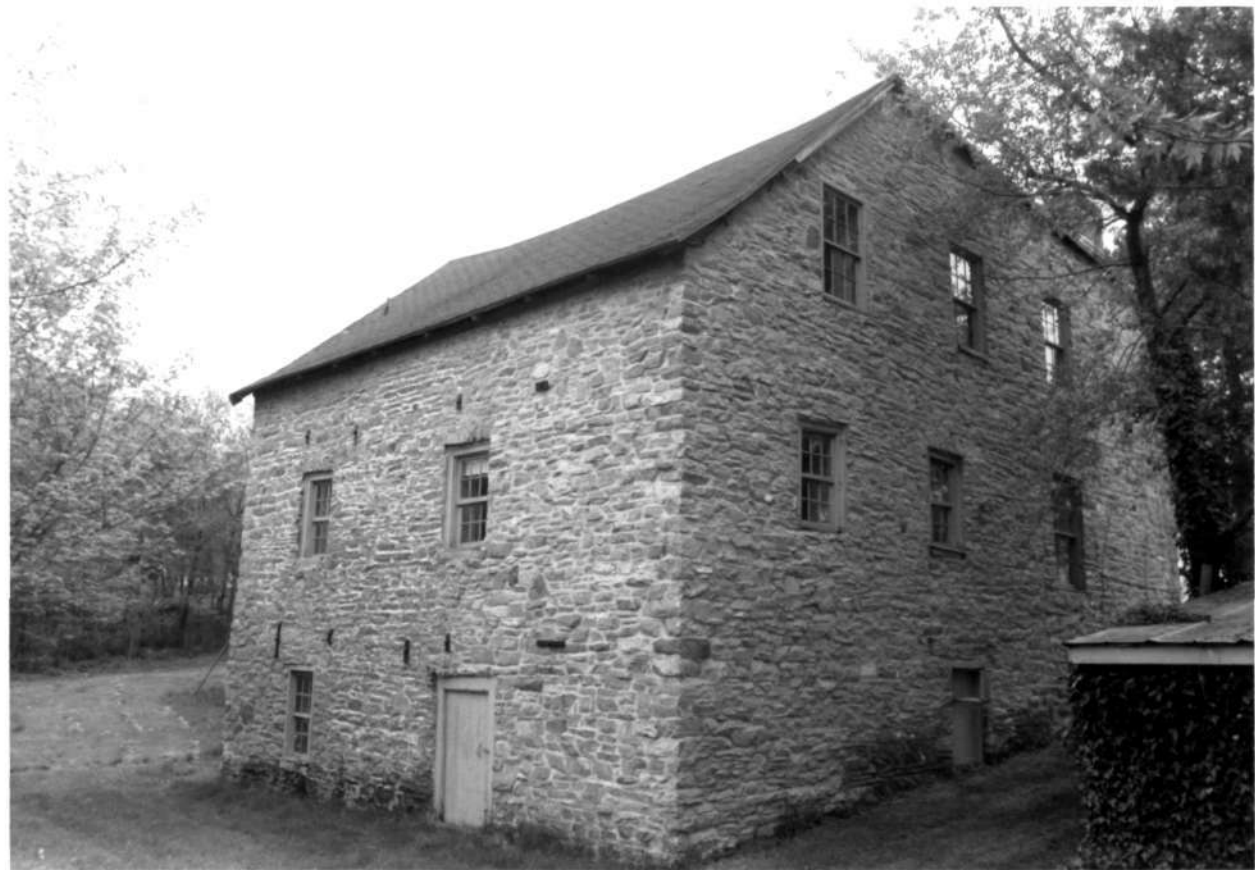
2/10

South west corner view

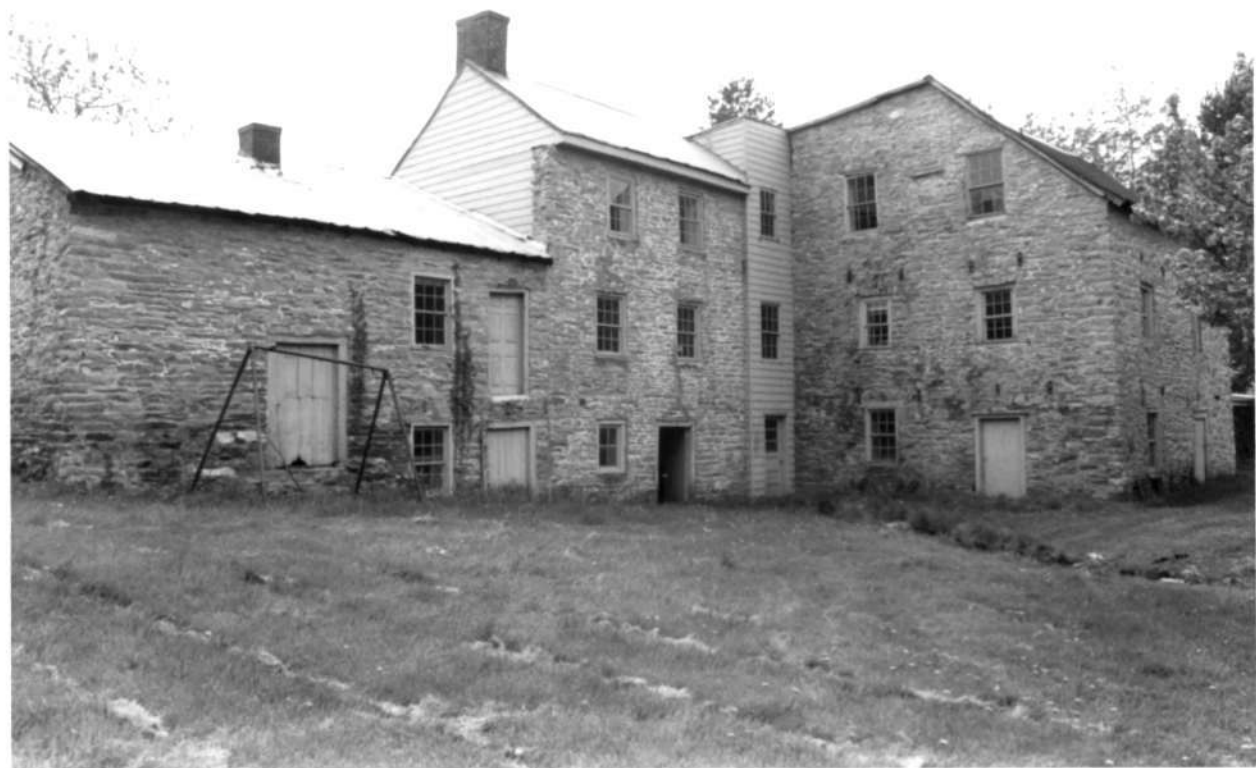
3/10

Northwest corner view

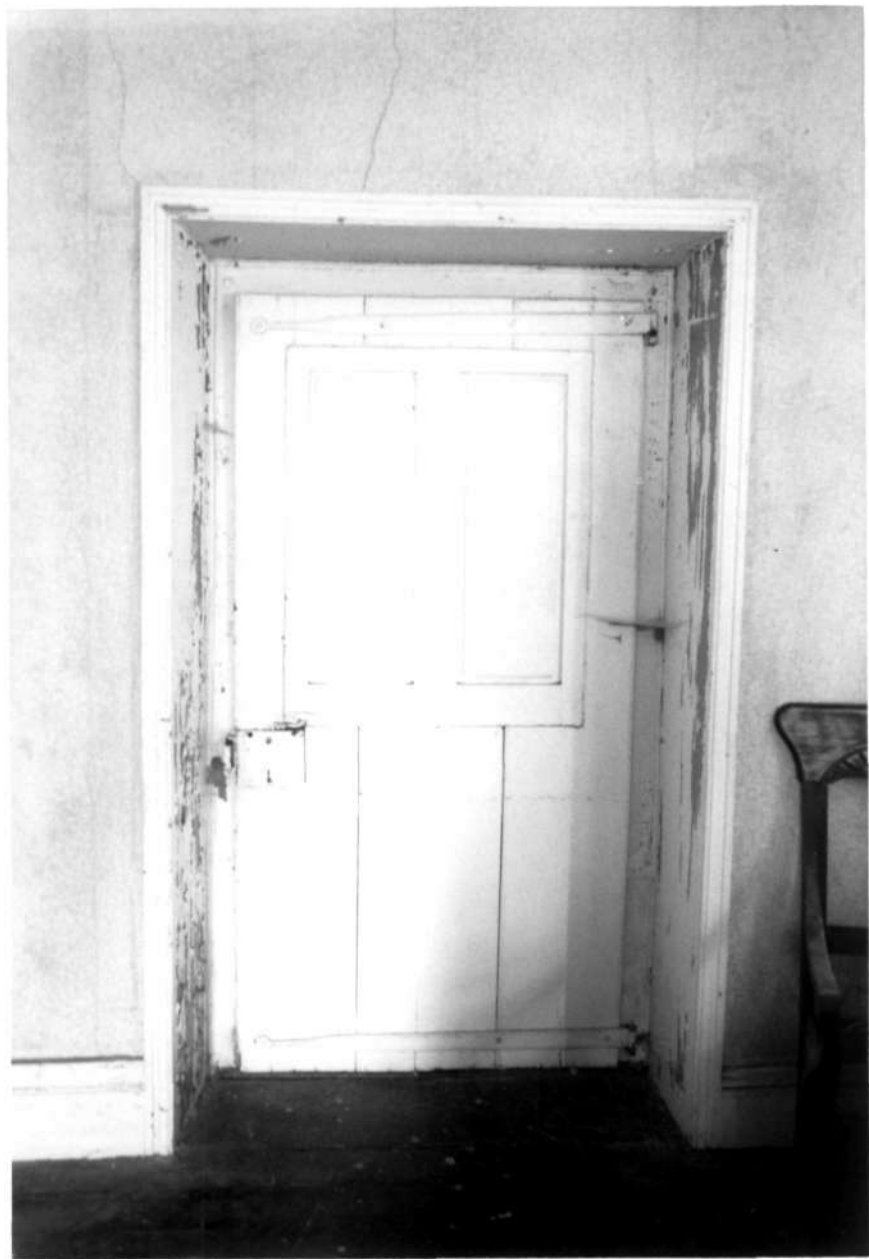
4/10

Original front door, viewed from original 1st  
floor interior

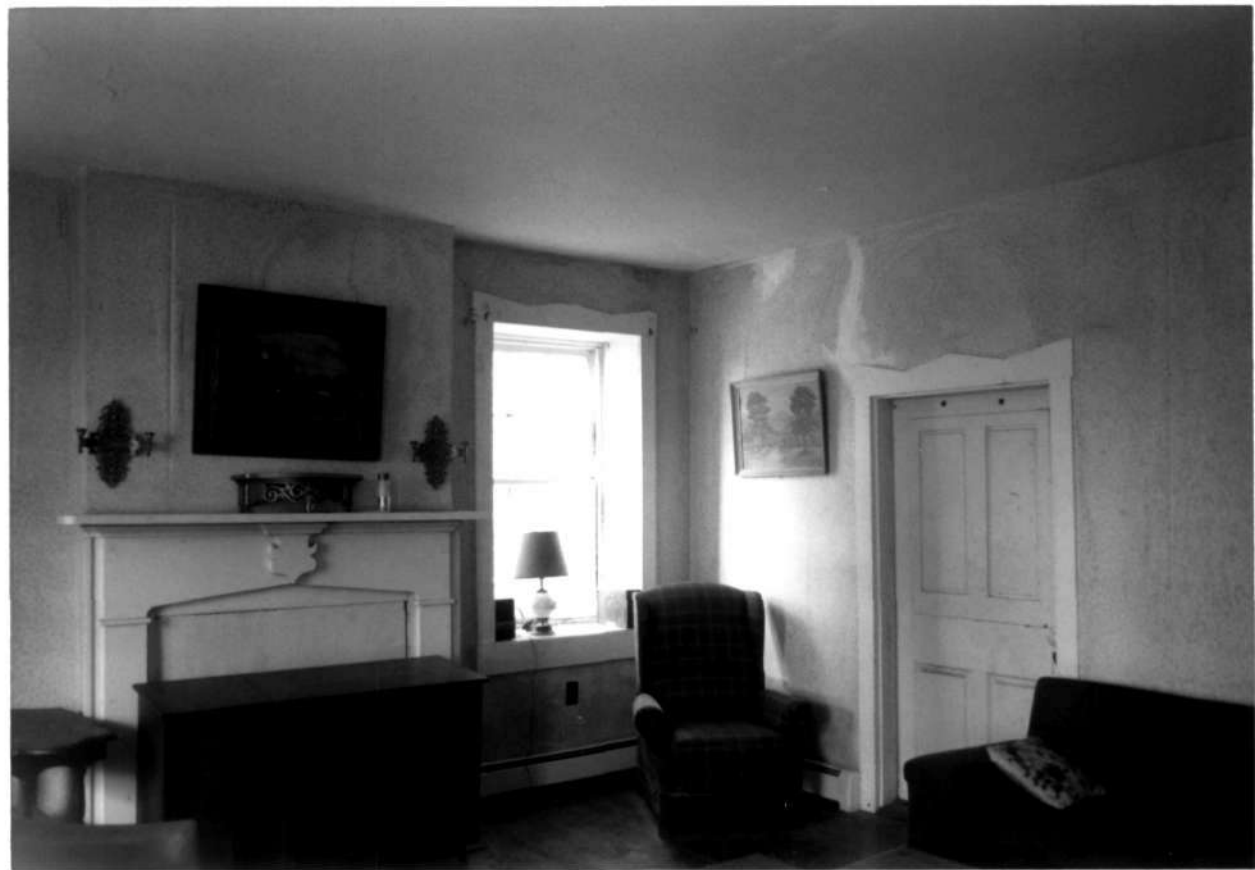
5/10

Interior of c. 1840 parlor

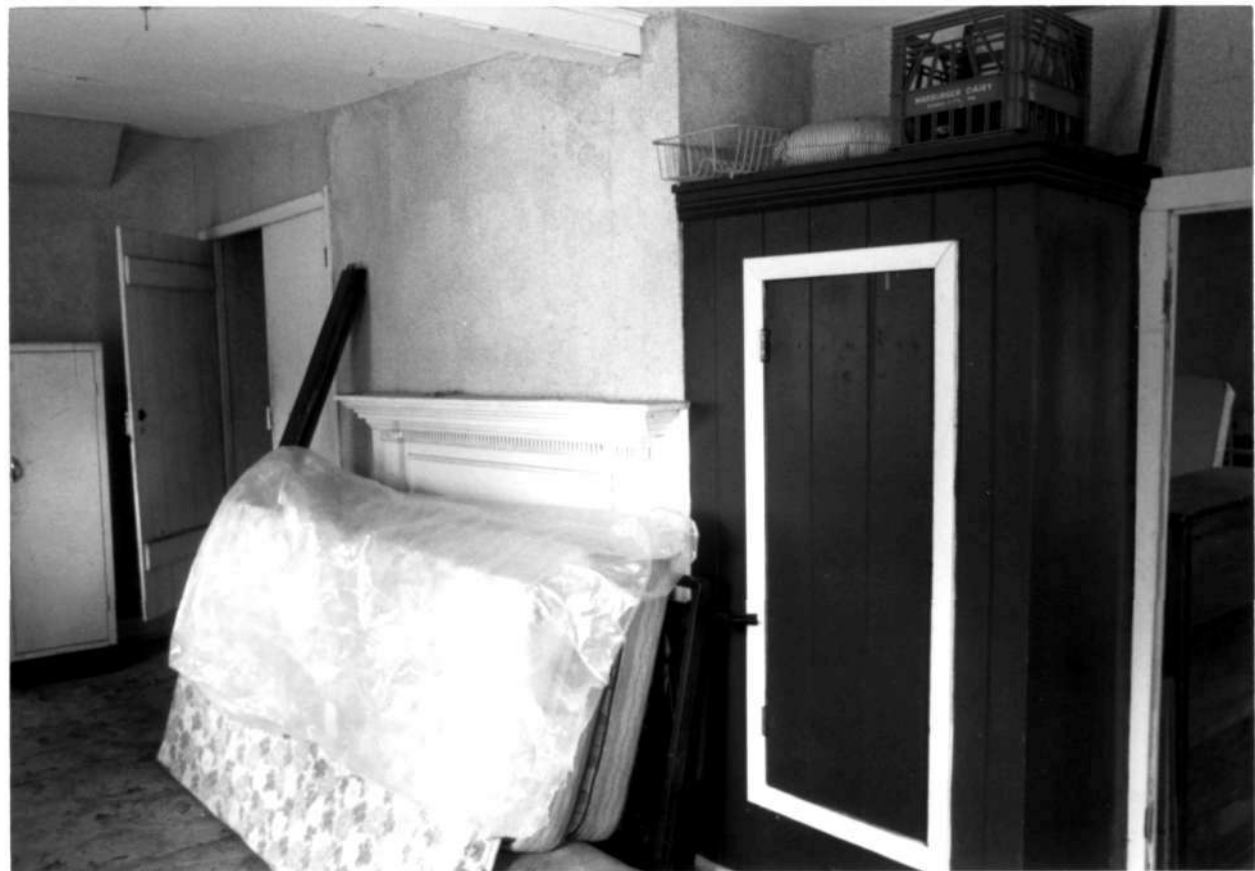
6/10

The first story of the original section has a single fireplace opening in the north room with a partial mantelpiece still in place, a paneled and dentiled shelf and frieze above the opening. The side pilasters or panels appear to be missing. The mantel appears to date from about 1775-1800. Next to the fireplace is the upper section of the dumb waiter which has a more finished appearance than the lower part. A molded cornice tops the enclosure and the vertical boards are painted green. The door opening has a white frame and the door has modern hinges. The south room has no fireplace opening, but an enclosed staircase in the northeast corner suggests that it once wrapped around the missing chimney projection. A corresponding door from the north room opens into the staircase landing. The walls of the first story are covered with mid-20th century wall paper. The window and door frames are simple moldings and each room has a molded baseboard. The floors are wide boards, with a 20th century linoleum covering in the north room. The original front door of the 1740's house, located in the south room, has a deep soffit on the west or original interior side, revealing the depth of the original exterior wall now enclosed by the 1840's addition. The door was originally three wide boards and the original strap hinges and box lock are still in place. The upper section of the door apparently was cut out, perhaps for a glazed upper panel or a dutch door, and later replaced with a raised panel infill.

Mantel in c. 1750 section, with dumb waiter  
at right

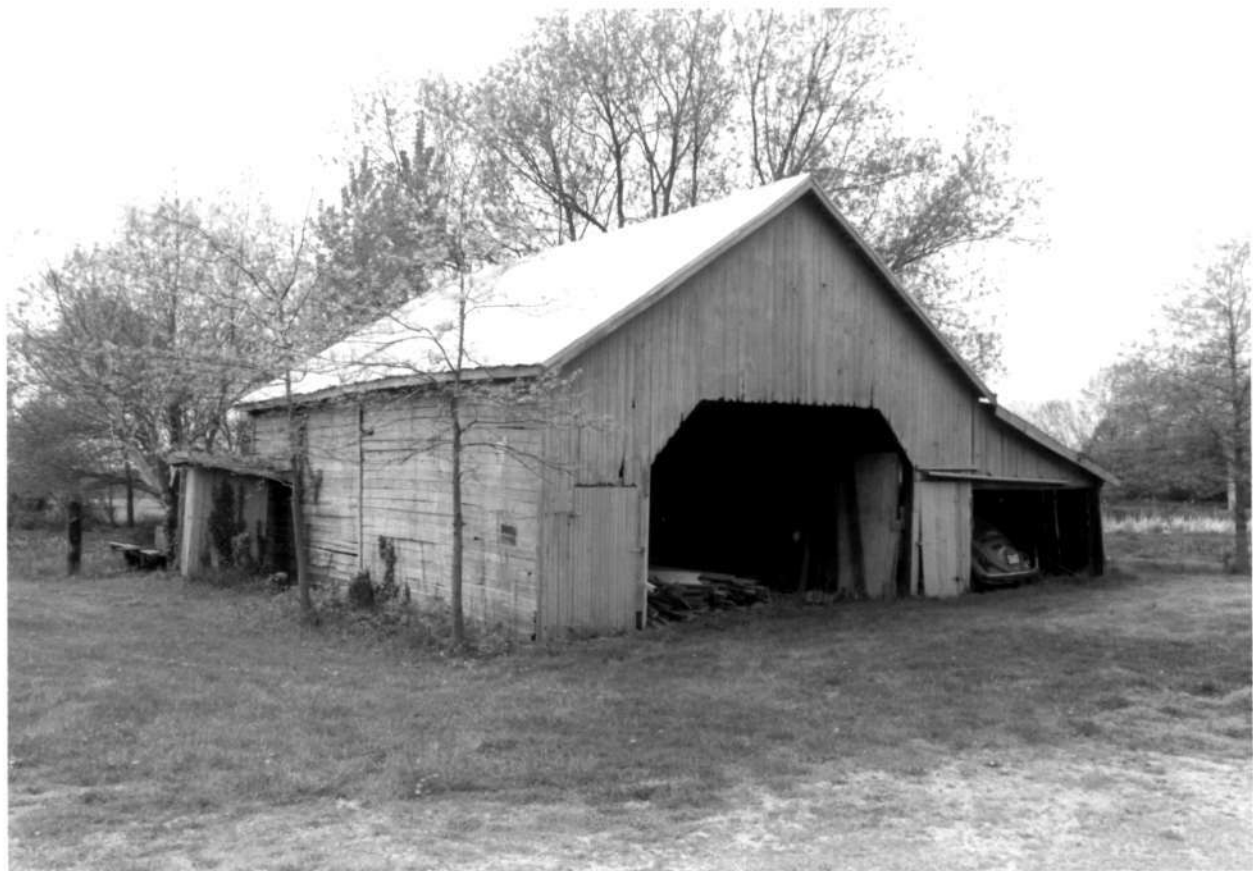
7/10

Wagon shed / corn crib, north elevation

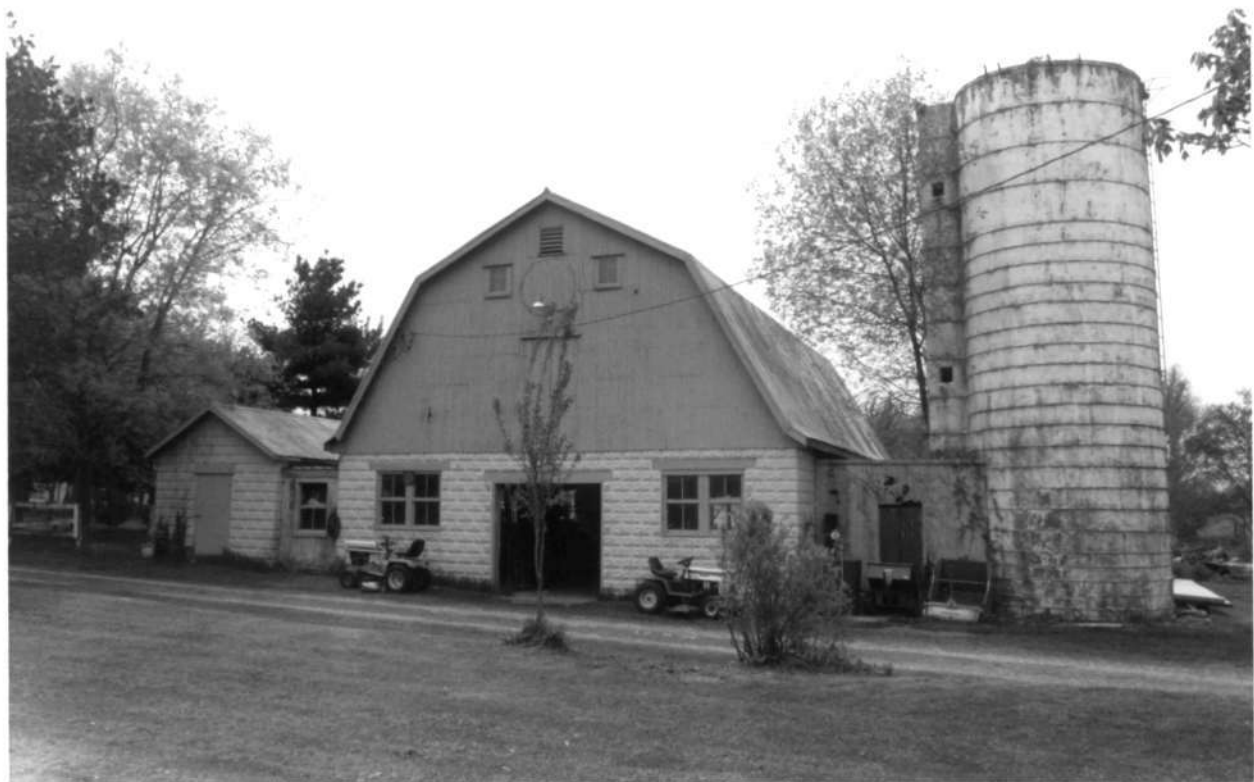
8/10

Dairy barn, milk house, and silo: The dairy barn located east of the wagon shed has a rusticated concrete block base with a frame upper structure with a gambrel standing seam metal roof. Paired 2/2 windows are located in the north elevation flanking the central doorway. The milk house on the east side of the barn is a one-story gable roofed building in rusticated concrete block with a corrugated metal roof. A single door is in the north elevation. Flanking the dairy barn on the west is a poured concrete silo. The dairy barn and milk house were built in the 1920's, and burned in 1954, leaving only the concrete block walls intact. The frame upper walls and roof were rebuilt and the silo was probably added at the same time.

Dairy barn & milk house, with silo, view  
from north

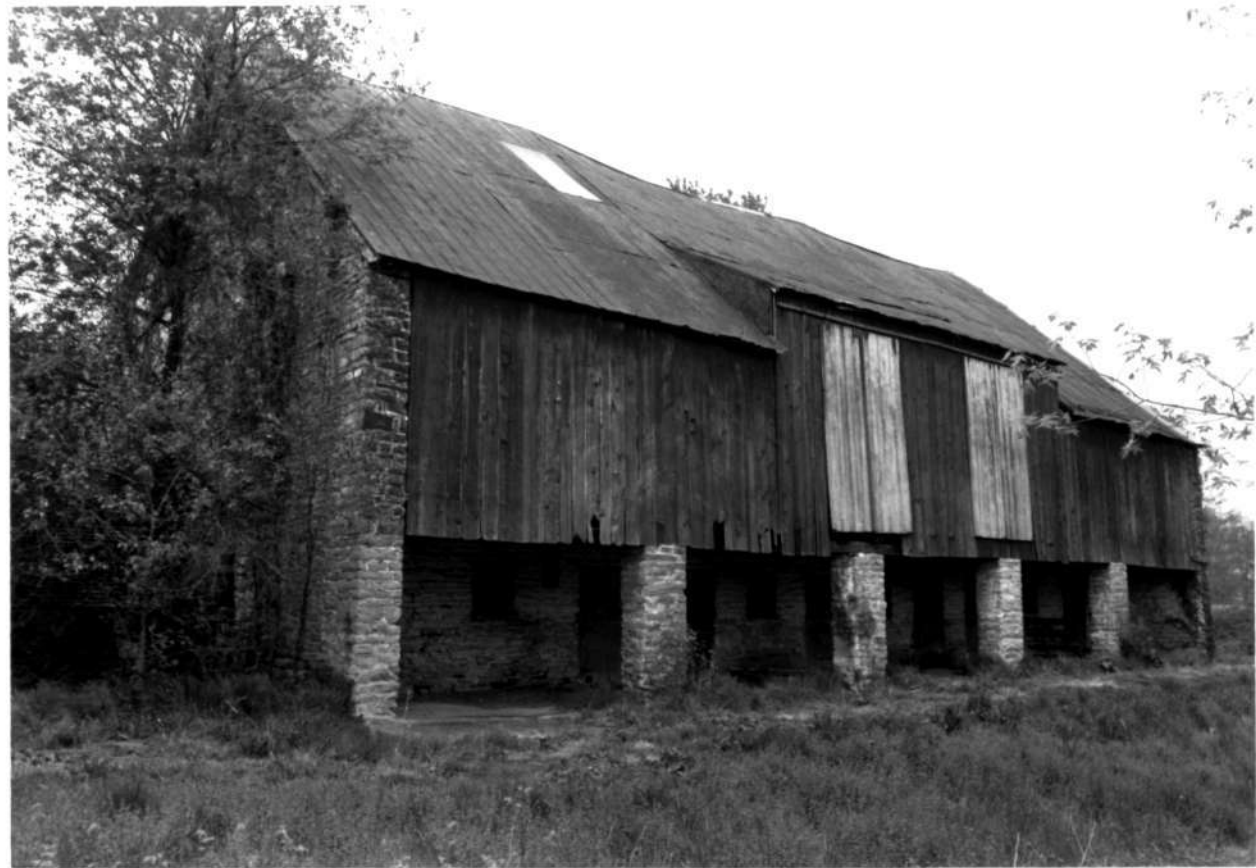
9/10

Bank barn, southeast corner view
